Street Operations
1080 South 1st Avenue
Pocatello, ID 83201
(208) 234-6250
(208) 234-6194
Fax: (208) 478-7152

TO: U.S. Army Corps of Engineers
DATE: July 31, 2010
FROM: City of Pocatello
RE: Portneuf River Levee Maintenance Bi-Annual Report

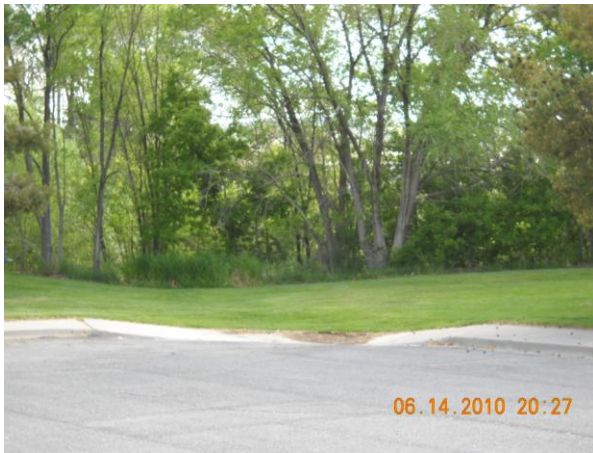
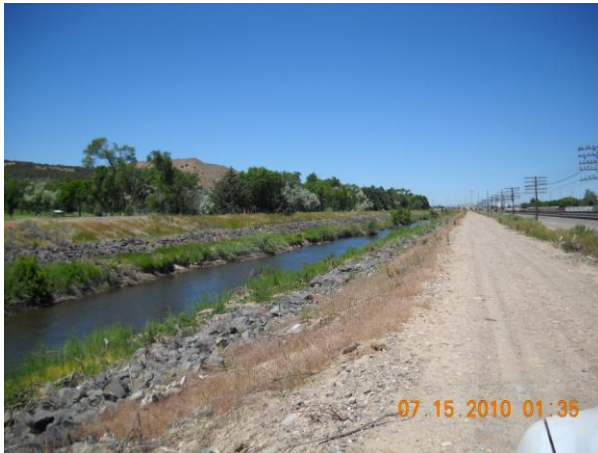
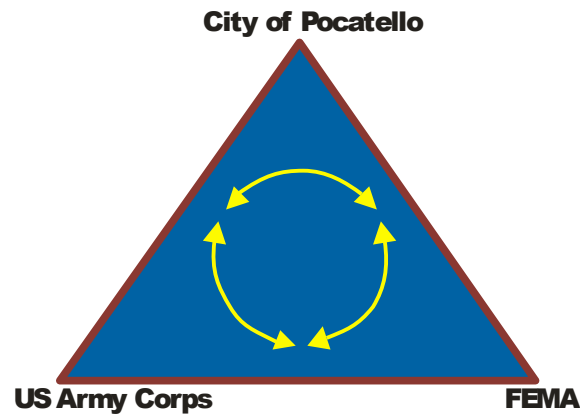
Vegetation—The vegetation on 12,500 feet of the levee remains overgrown and untouched at this time and could be a visual inspection deterrent during high flows or normal inspection.

Since February of 2010, we have completed an additional 11,874 feet of vegetation management along the levee system.

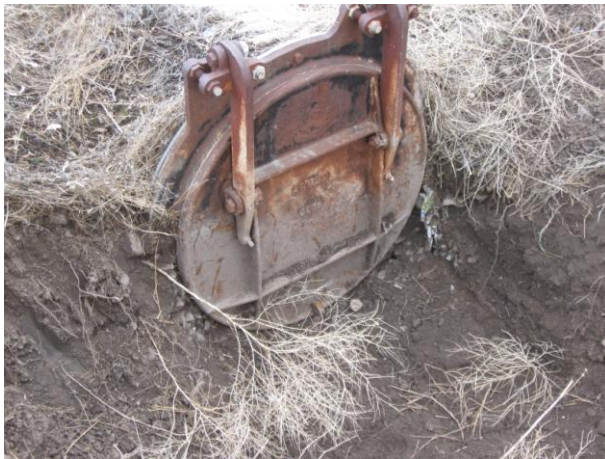
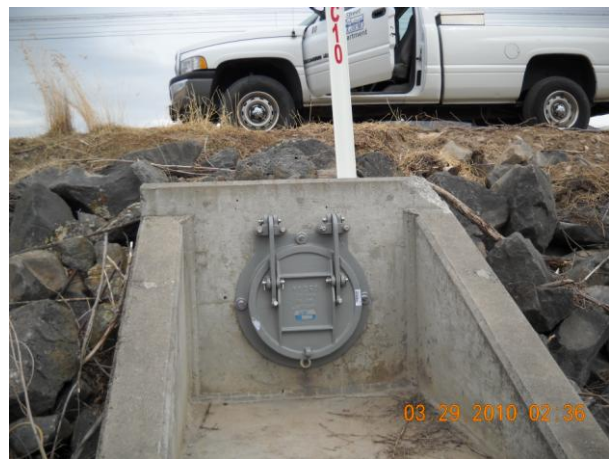
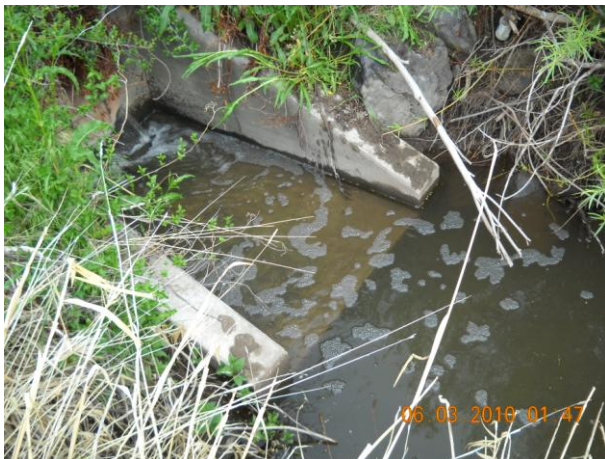
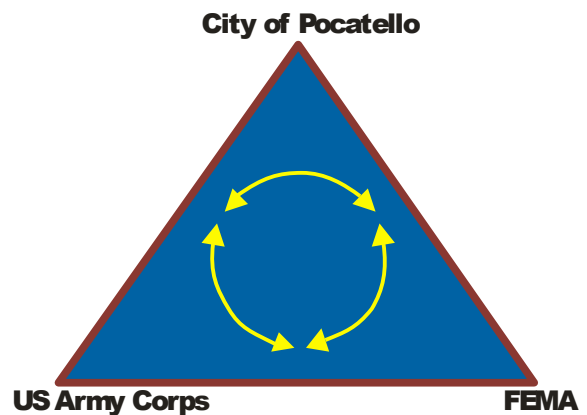
We currently have 29 inoperable flap gates that have silt and debris blocking the outlets.

All closures have been marked with a number that coincides with a map provided in the Williams Engineering report. These closures have also been marked with a sticker that provides the inspection and exercise date. To date we have repaired 5 closures.
